**TECHNICAL MEMORANDUM 001**  
(consists of 4 pages)  
**SITE INSPECTION EXPECTATIONS**  
**BASIC STEEL WORKS SUPPORTS OVER OPENINGS**

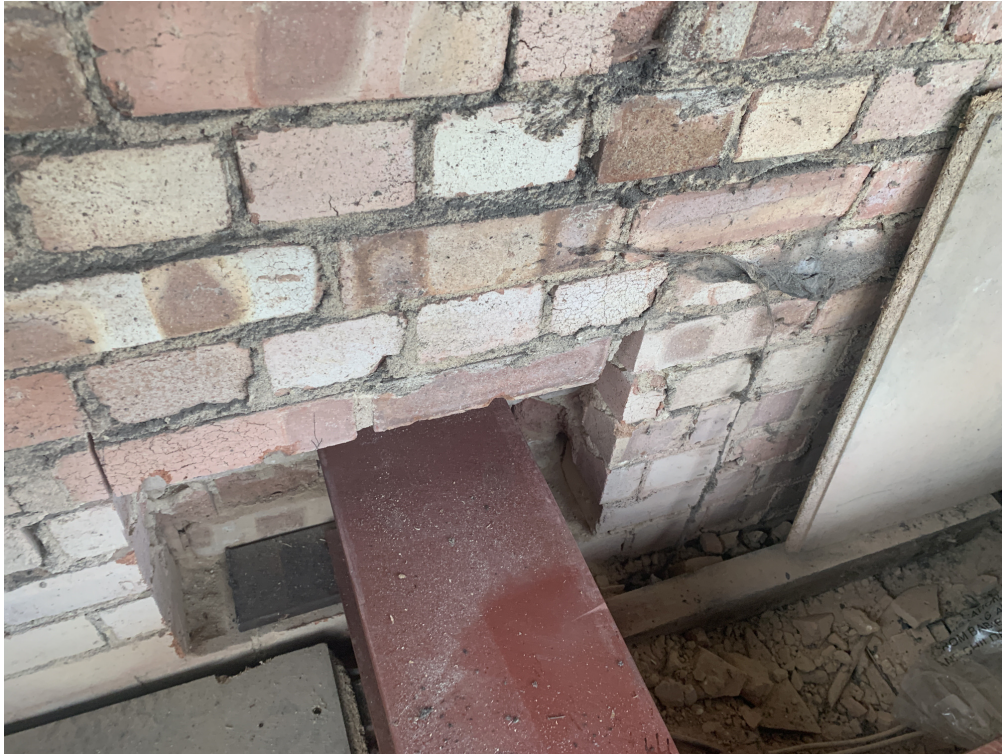
**001 A GOOD EXAMPLE OF A STEEL BEAM BEARING POCKET MADE READY FOR INSPECTION :** Steel beam (painted red) with end bearing 100mm into a party wall, on a mild steel plate (unpainted). The brickwork has been cut using a diamond tipped rotary disc to produce a clean cut with minimal disruption to the brickwork.

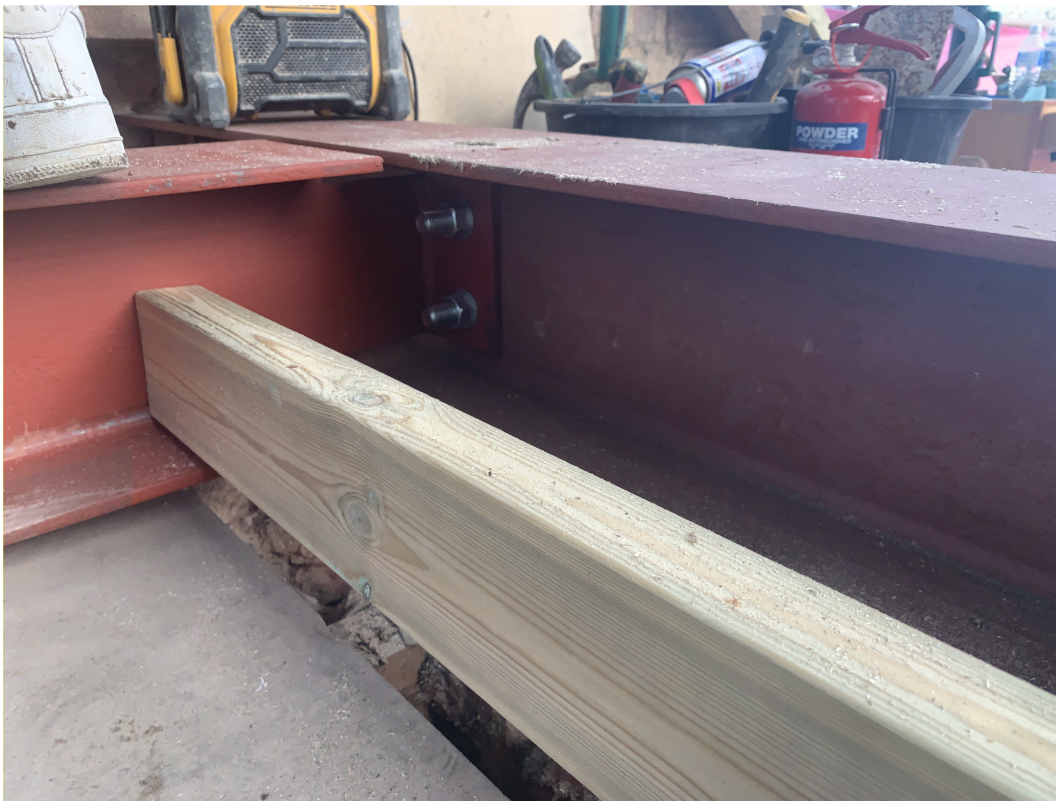
**002 A GOOD EXAMPLE OF STEEL BEAM CONNECTION :** Steel beam bolts clearly visible

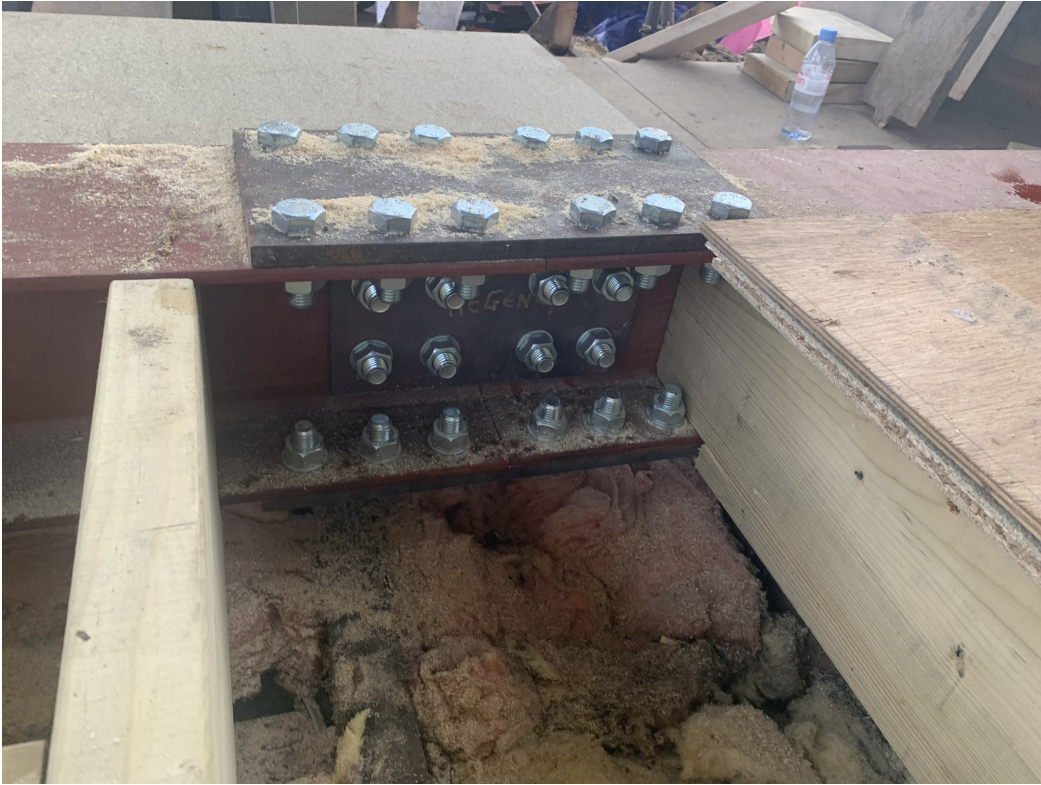
**003 A GOOD EXAMPLE OF STEEL BEAM CONNECTION :** Steel beam connection splice bolts clearly visible

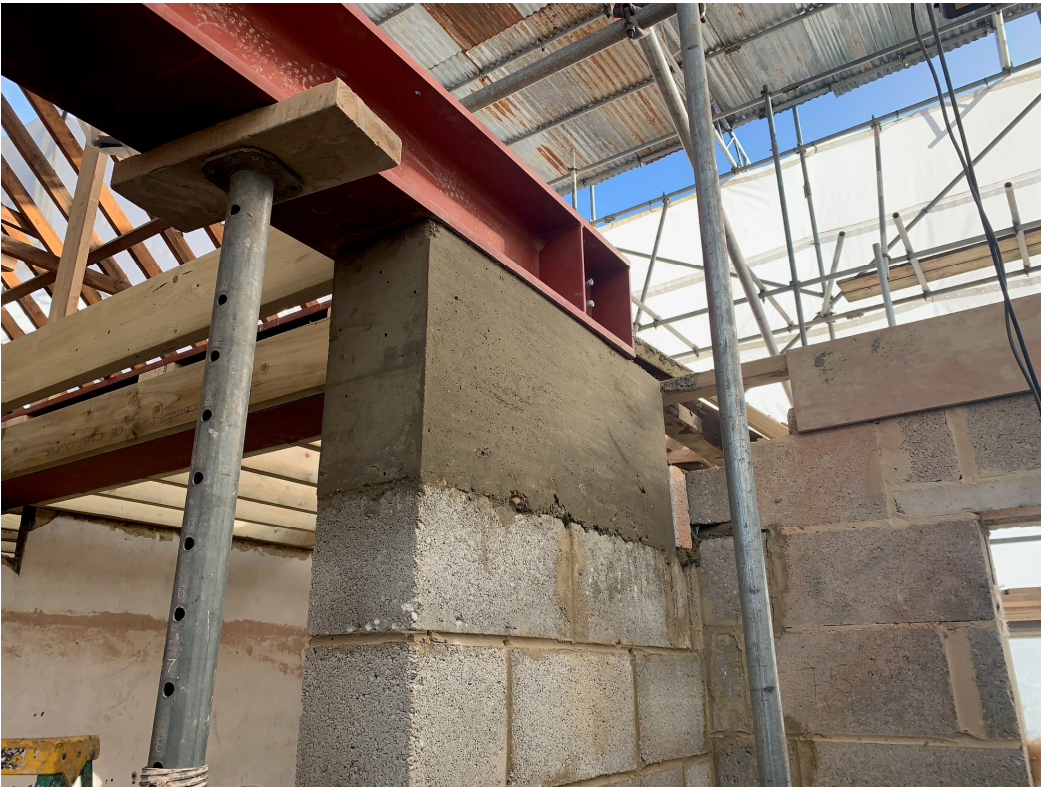
**004 A GOOD EXAMPLE OF STEEL BEAM RESTING ON A CONCRETE PADSTONE :** Steel beam resting on a cast in situ concrete padstone which rests onto dense concrete blockwork walls.

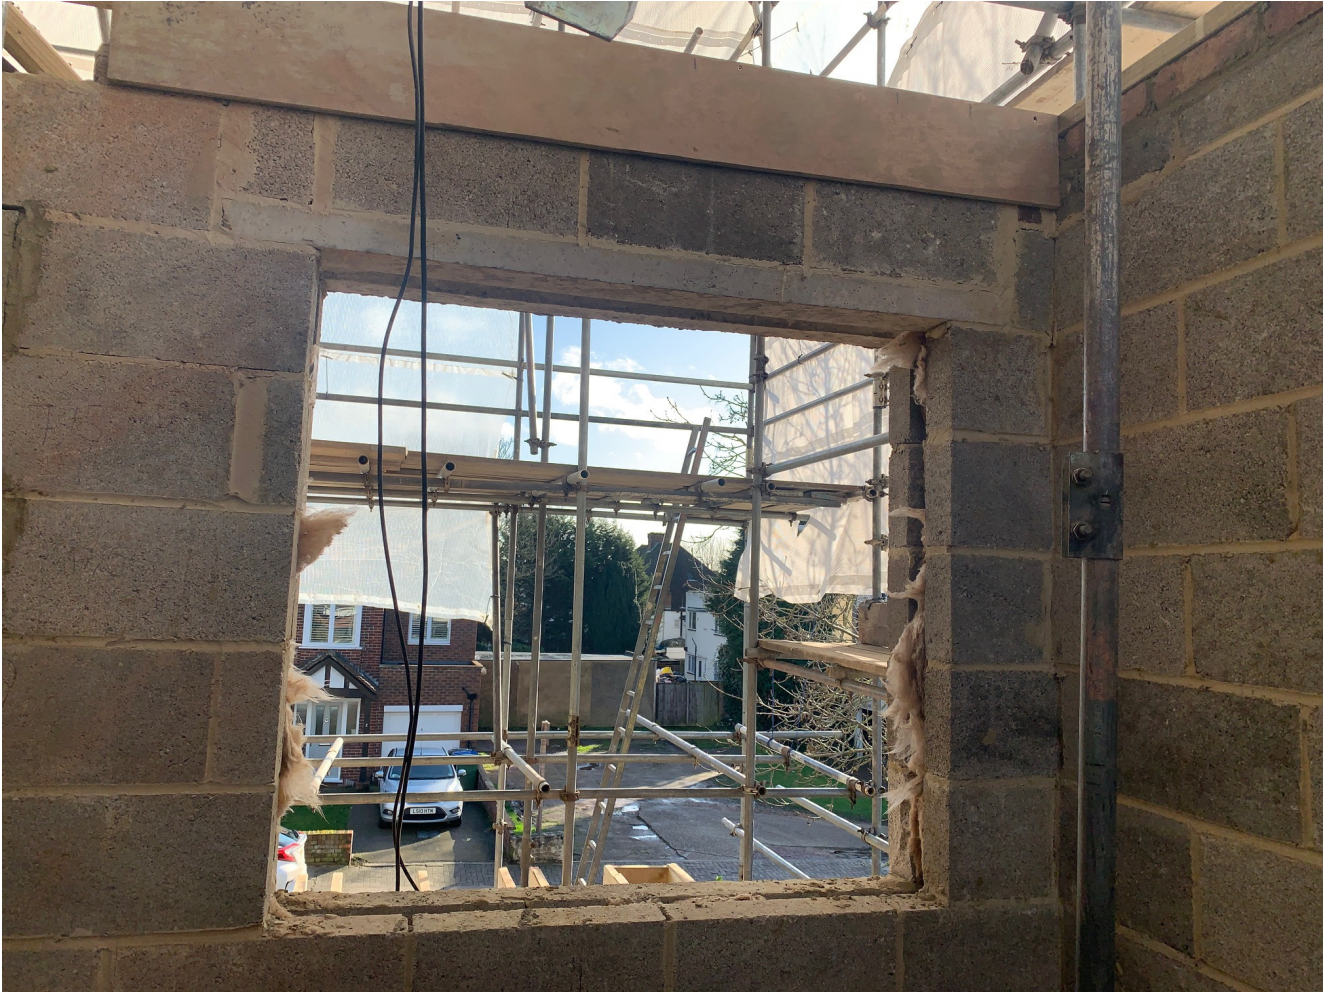
**005 A GOOD EXAMPLE OF CONCRETE LINTOL FITTED OVER A WINDOW OPENING:** The lintol bearings in this image are clearly visible .
